IMAGES IN GYN ULTRASOUND

How to identify and localize IUDs on ultrasound

➡ ObGyns—many of whom have access only to 2D ultrasound—are increasingly called upon to determine the positioning, or malpositioning, of the device. Here, an at-a-glance guide for properly placed and malpositioned IUDs.

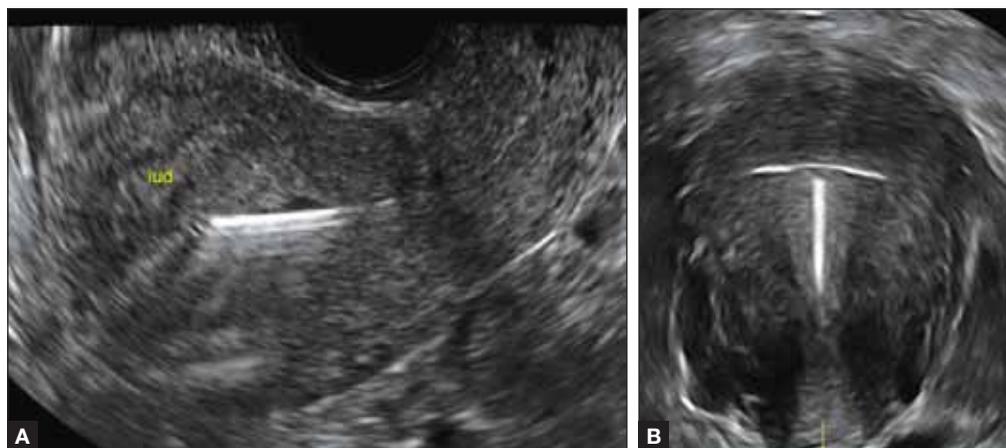
FIGURE 1 Well-positioned copper IUD

A. 2D (sagittal) and (B.) 3D images show the uniformly echogenic stem.

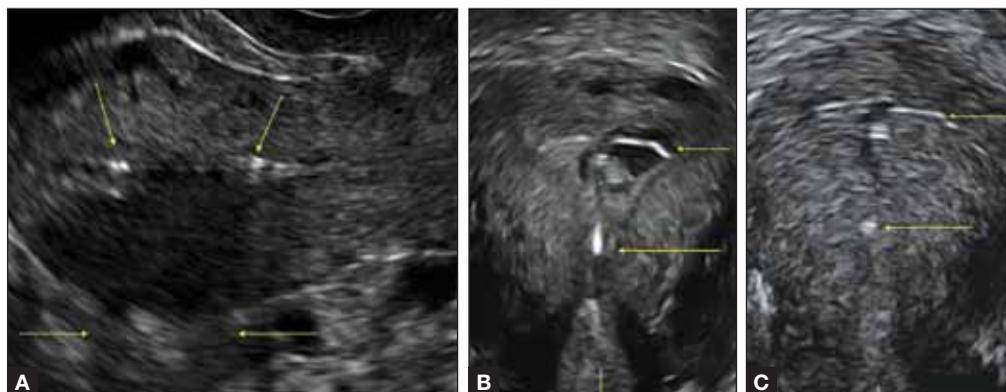
FIGURE 2 Well-positioned Mirena IUD

Note the echogenic superior and inferior ends of the stem with posterior acoustic shadowing in 2D view (A.) and 3D views (B. and C.).

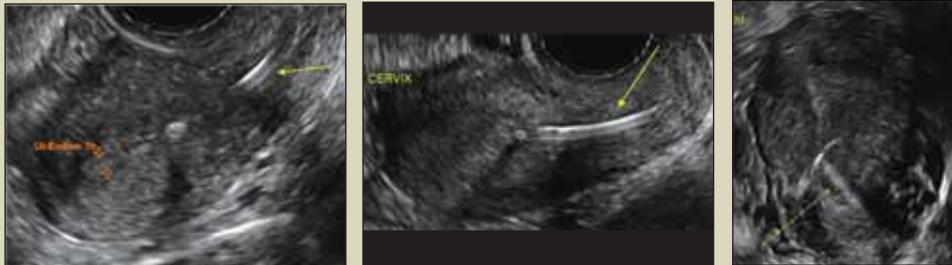
CASE 1 Dyspareunia

A patient with a copper IUD reports pain with intercourse. Sagittal and 3D sonographic views show the IUD in the lower uterine segment and endocervical canal. The IUD is removed in the office.

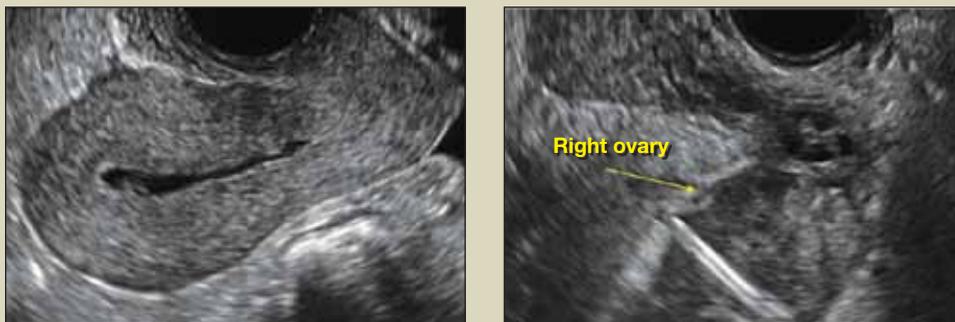
CASE 2 Extrauterine IUD

Upon imaging, a copper IUD is found to be entirely extrauterine, due to perforation, in the region of the right adnexa. The IUD is removed laparoscopically from the right fallopian tube, where it was extruding through the fimbriae.

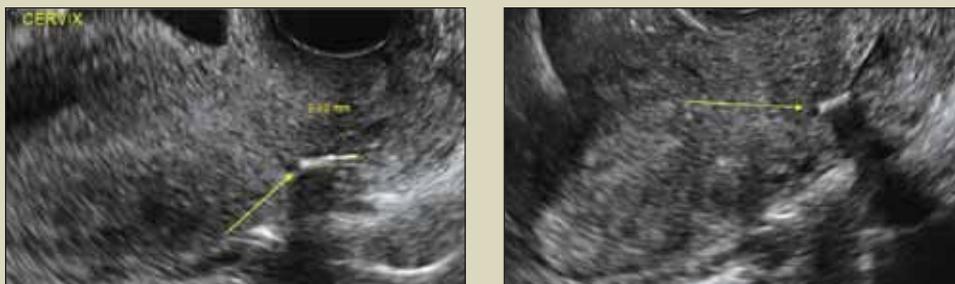
CASE 3 Incomplete IUD

A patient wishing to conceive requests removal of her copper IUD, which has been in place for 7 years. A non-intact IUD is removed, minus its right arm, which is imaged in the endocervical canal. The fragment can be removed during hysteroscopy or under sonographic guidance.

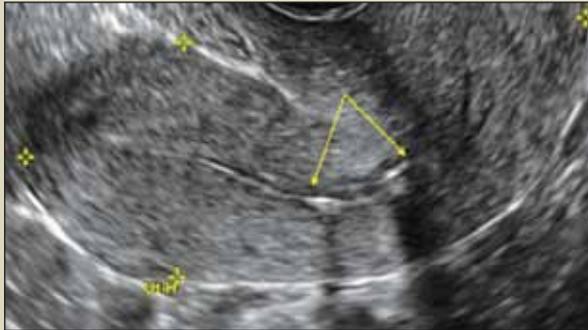
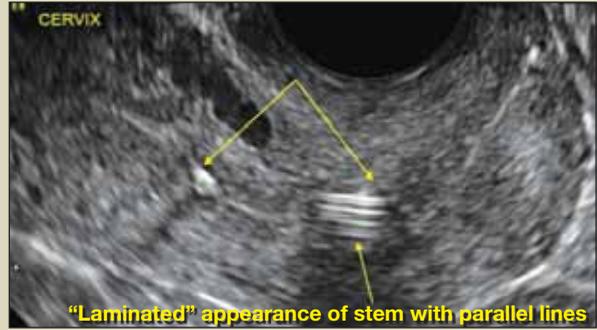
CASE 4 IUD in lower uterine segment

During imaging, the superior component of the Mirena IUD is found to be in the lower uterine segment, with the inferior component located in the endocervix.

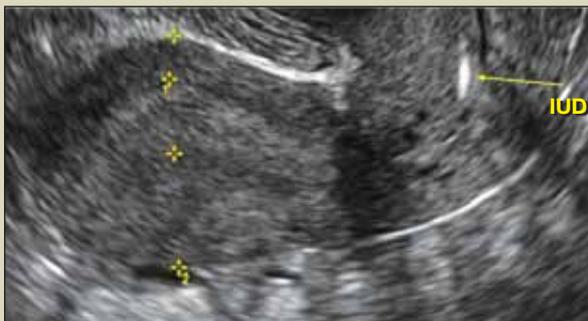
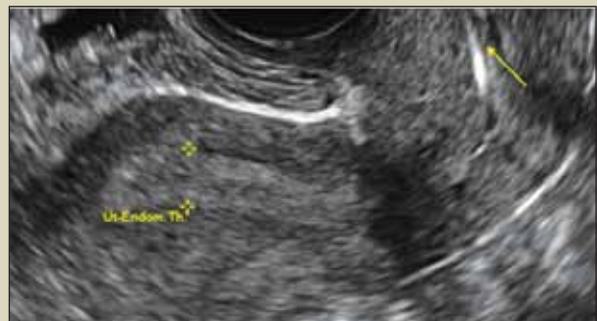
CASE 5 Displaced IUD

A patient with prominent posterior adenomyosis has a Mirena IUD displaced into the cervix. Adenomyosis increases the likelihood of IUD expulsion.⁴

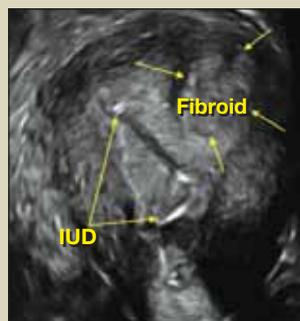
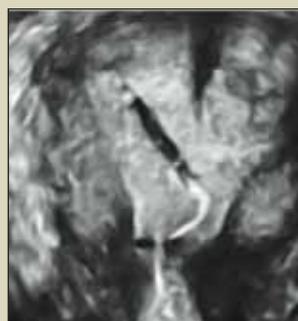
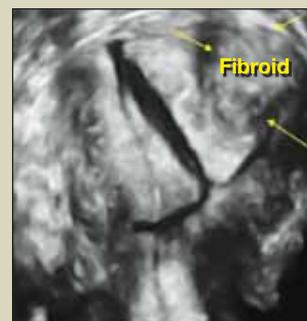
CASE 6 IUD displaced by fibroid

A patient with a malrotated Mirena IUD is found to have a submucosal fibroid, which has displaced the IUD. After removal of the IUD, the fibroid is resected hysteroscopically.

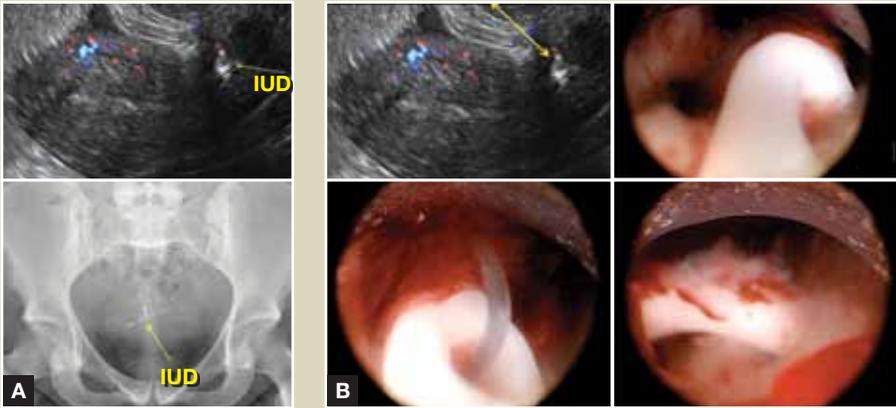
CASE 7 Patient referred for additional imaging

A patient who reports dysmenorrhea 2 years after placement of a Mirena IUD brings outside ultrasound and computed tomography (CT) reports that conflict. The ultrasound report says no IUD was found in the uterus, and the CT report says “IUD noted in uterus.” A. Abdominal flat plate radiography and a new transvaginal ultrasound are performed. The IUD is not imaged in the endometrial cavity, but hyperechoic structures are noted in the endocervix. B. A hysteroscopy of the same patient reveals the Mirena IUD curled up with both ends of the crossbar and the inferior end of the stem embedded at the internal cervical os, consistent with the ultrasound imaging.
