Failed First Metatarsophalangeal Arthroplasty Salvaged by Hamstring Interposition Arthroplasty: Metallic Debris From Grommets

Kurt V. Voellmicke, MD, Manjula Bansal, MD, and Martin J. O'Malley, MD

Am J Orthop. 2008;37(2):E42-E45. Copyright Quadrant HealthCom Inc. 2008. All rights reserved.

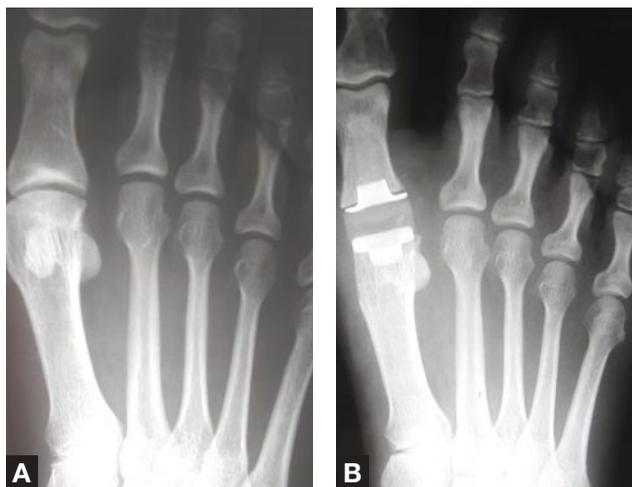
Preoperative x-rays showed a well-seated implant with no evidence of osteolysis. Comparison of preimplant and postimplant x-rays demonstrated that the great toe was minimally lengthened (Figure 1). This overlengthening was clinically obvious, especially when compared with the contralateral hallux.

Figure 1. Preoperative (A) and postimplant arthroplasty (B) anteroposterior x-rays show well-seated components without gross evidence of osteolysis but with mild overlengthening of the hallux.

This marked metallosis is likely caused in part by the relative lengthening of the hallux after the primary procedure. Increasing hallux length leads to increased tension in flexor and extensor tendons—not only decreasing joint motion but also increasing forces at the bone–grommet interface. In this case, though osteolysis was not clinically obvious 7 months after the implant arthroplasty, with more time it likely would have become apparent. We feel that adequate bone resection should be done to maintain adequate soft-tissue balance and motion. Kampner³ recognized overlengthening as a problem but was more concerned about the stress it places on bones—believing it leads to increased implant subsidence and shortening. In addition, the silicone hinge was inserted upside down, contrary to the original technique of Swanson and colleagues.¹ Gould²¹ described inserting a double-stemmed silicone implant with the hinge upside down in rheumatoid patients to increase power toward the floor. Doing this would seem only to increase the shear forces at the interfaces as the hallux is forced into dorsiflexion. In higher-demand patients without rheumatoid arthritis, positioning of the component in this fashion might adversely affect outcome.

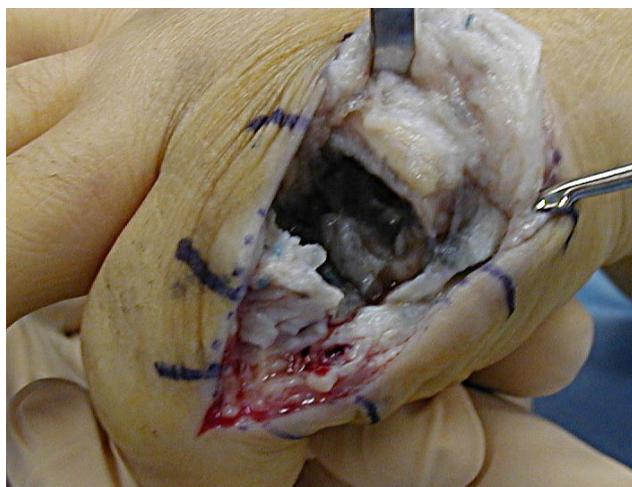
Immediately obvious on entering the joint was mild wear on the dorsum of the silicone hinge, which had been placed upside down. More significantly, however, there was marked metallosis distributed throughout the

Figure 2. Black metallic debris encountered within the first metatarsophalangeal joint.

entire joint, with blackish fluid in the joint. Removal of the grommets exposed bony surfaces blackened by metallic debris (Figure 2). Small curettes were used to débride the bony surfaces, and the joint was thoroughly irrigated with antibiotic solution after appropriate cultures were obtained.

Up until now, there have been no reports of titanium debris in the setting of first MTPJ implant arthroplasty. Titanium wear and particulate debris have been well documented in total hip arthroplasty, however, and an early report from our institution details the histology of titanium particulate debris and its corresponding cellular response.¹² Many similar histologic findings are identified in this case, including a prominent histiocytic response with foreign-body giant cells and metallic debris within histiocytes. Although silicone particles are usually considered to be the primary cause of reactive synovitis, it seems likely that the metallic debris in this case was at least in part responsible for the pain and inflammation about the IPJ and the MTPJ.

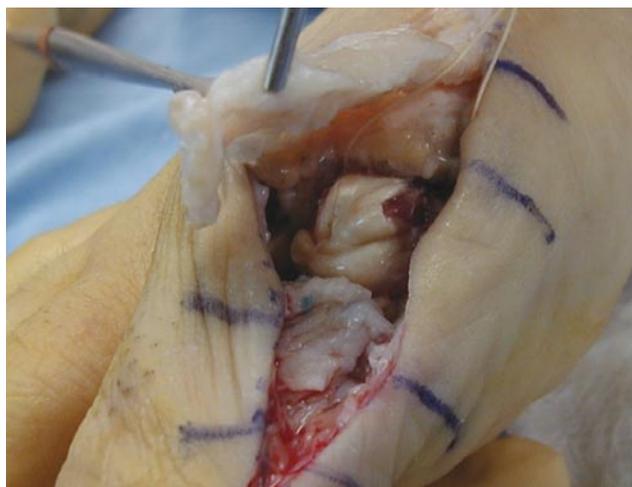
Approximately 15 to 18 cm of ipsilateral semitendinosus tendon was harvested using a tendon stripper. A 2-0 Vicryl suture was used to create an “anchovy” from the tendon graft. After both bony defects were filled with Allomatrix (Wright Medical Technology, Arlington, Tenn), the dorsal capsule was elevated, and the semitendinosus graft was stabilized within the joint by suturing it to the plantar soft tissues. Next, the dorsal capsular tissue was sutured to the plantar capsule over the interposed tendon graft (Figure 3). Intraoperative dorsiflexion was approximately 50°.

Figure 3. Autogenous ipsilateral semitendinosus “anchovy” in place.

of the extensor hallucis longus or a piece of the gastrocnemius aponeurosis.²⁴ Because the plantaris tendon is absent in 10% to 60% of patients²⁵ or, when present, often quite thin, we have found that harvesting a hamstring tendon from the ipsilateral lower extremity to be more predictable and satisfying. It also allows creation of an “anchovy” of sufficient size to substitute for the relatively larger amount of resected bone for implant arthroplasty as compared with primary interposition arthroplasty. This is not unlike using the flexor carpi radialis tendon for basal joint arthritis.

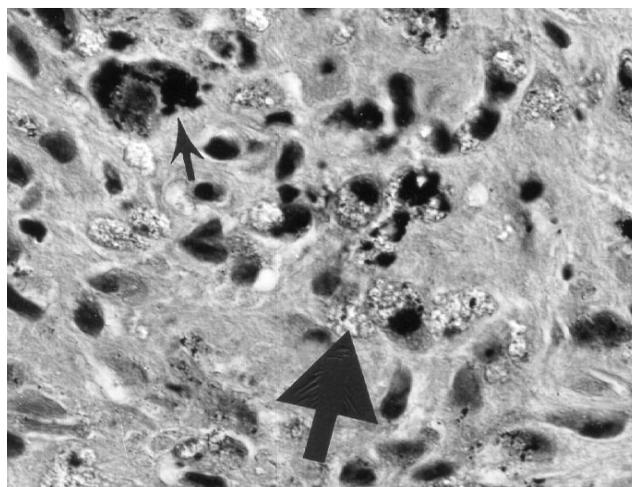
Figure 4. Histiocytic and foreign-body giant-cell reaction to silicone (large arrow) and metallic debris (small arrow). Hematoxylin-eosin, original magnification $\times 40$.

moderately hyperplastic and hypervascular. Numerous foci of marked histiocytic and foreign-body giant-cell reaction to metallic debris and nonrefractile silicone polymer were present (Figure 4).

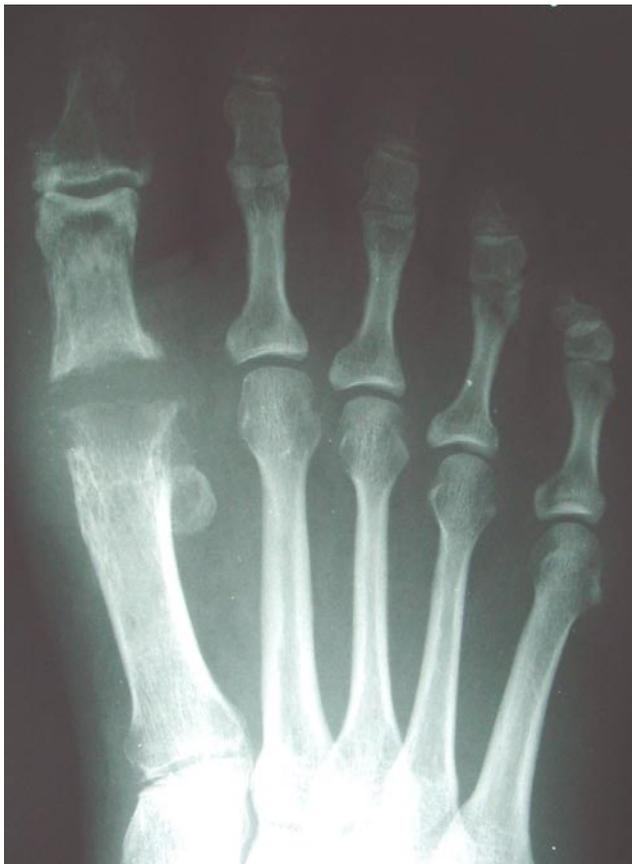
At 1-year follow-up, the patient had no complaints and demonstrated 55° of dorsiflexion and 5° of plantarflexion at the first MTPJ. Postoperative standing x-rays showed good alignment of the hallux and restoration of the length of the first ray (Figure 5).

Figure 5. Follow-up standing anteroposterior x-ray shows good alignment of hallux and restoration of appropriate resting length.
